Fiber Solutions

Pulper & Separator Rotor Repair

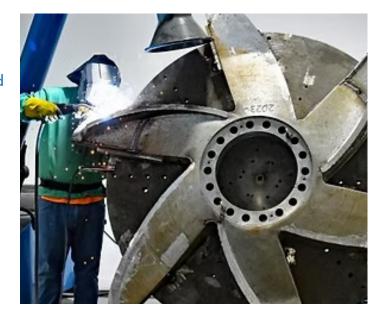
- Inspect and straighten if needed
- 309 or 316 weld wire to replace worn metal and repair cracks
- **STOODY** Hard facing & wear resistant weld applied to wear areas
- Diamond wheel profile & grind
- Blanchard grind bottom, rebore (if needed) and balance
- Regional pick-up and delivery
